# **GEOTECHNICAL ENGINEERING REPORT**

**LIFECORE DRIVE SHARED USE FACILITY  
LIFECORE DRIVE  
AUGUSTA COUNTY, VIRGINIA**

**JOB NUMBER: 34049.001**

**April 15, 2016**

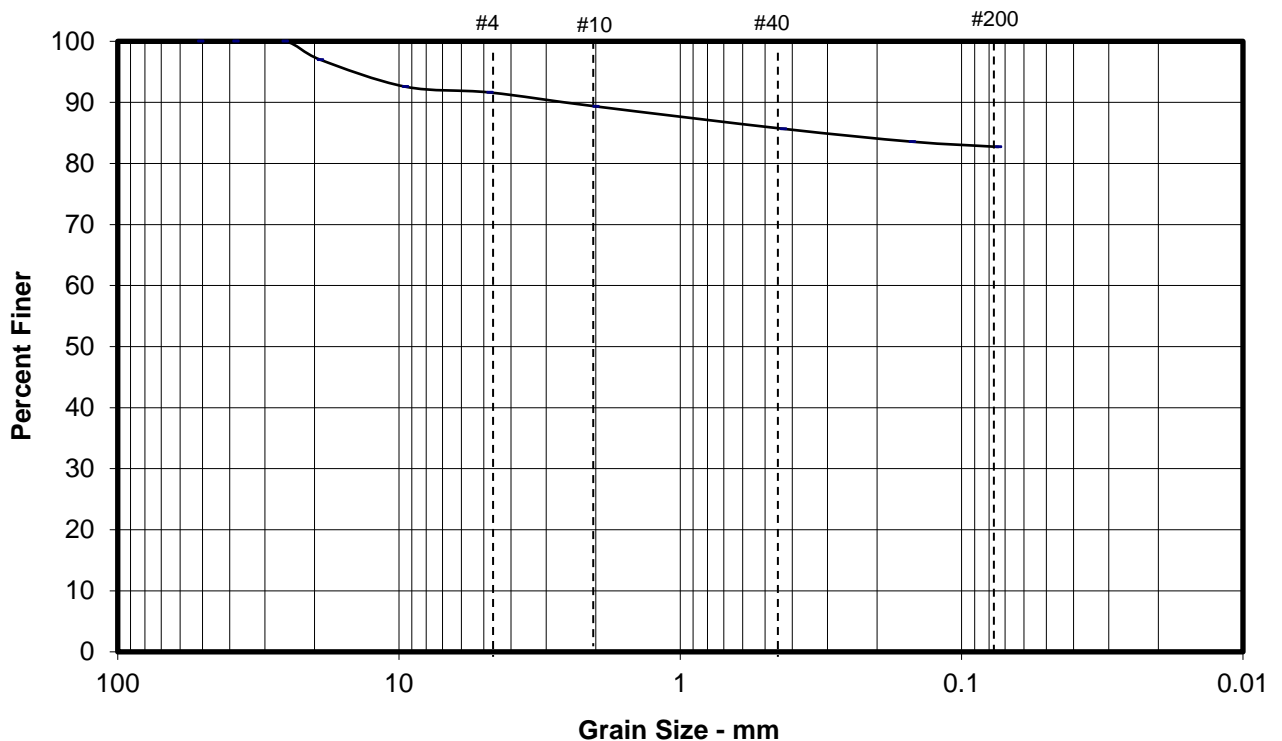
FIGURE NUMBER GS4

Liquid Limit	Plastic Index	USCS	AASHTO
<b>63</b>	<b>32</b>	<b>CH</b>	<b>A-7-5 (14.9)</b>

Percent Gravel	Percent Sand	Percent Silt and Clay
<b>8.4%</b>	<b>8.9%</b>	<b>82.7%</b>

Material Description	Fat CLAY with Sand
Natural Moisture	29.5%
SPT Blow Counts	N/A

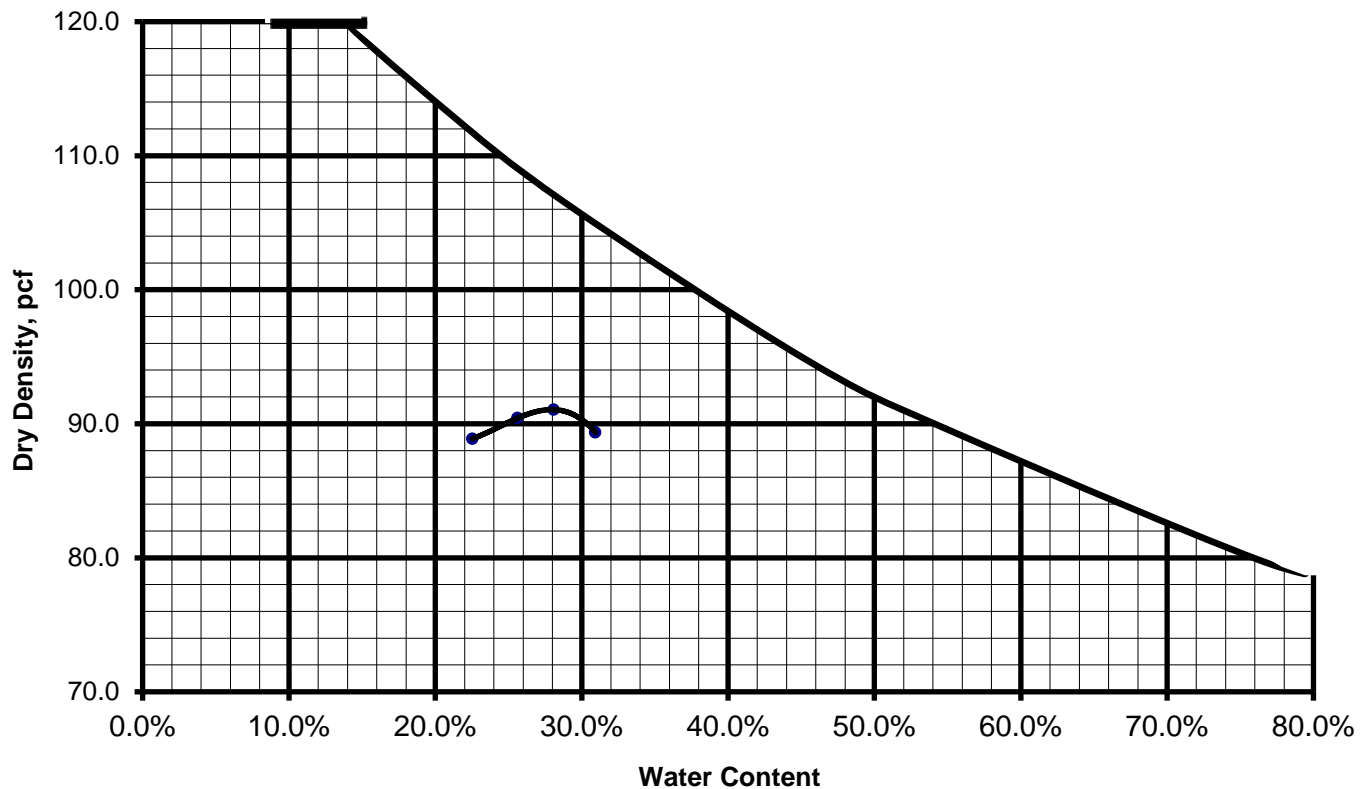
FIGURE NUMBER PR2

Based on the Atterberg limits testing, the bulk sample is of high plasticity. Based on comparison of the natural moisture content to the optimum moisture content of the bulk sample, near-surface soils appear wet of optimum moisture. Drying of some near-surface soils will be required prior to their re-use as fill.

Uncorrected	Rock Corrected Results
Maximum Dry Density, pcf	91.2	93.5
Optimum Moisture	28.0	26.5

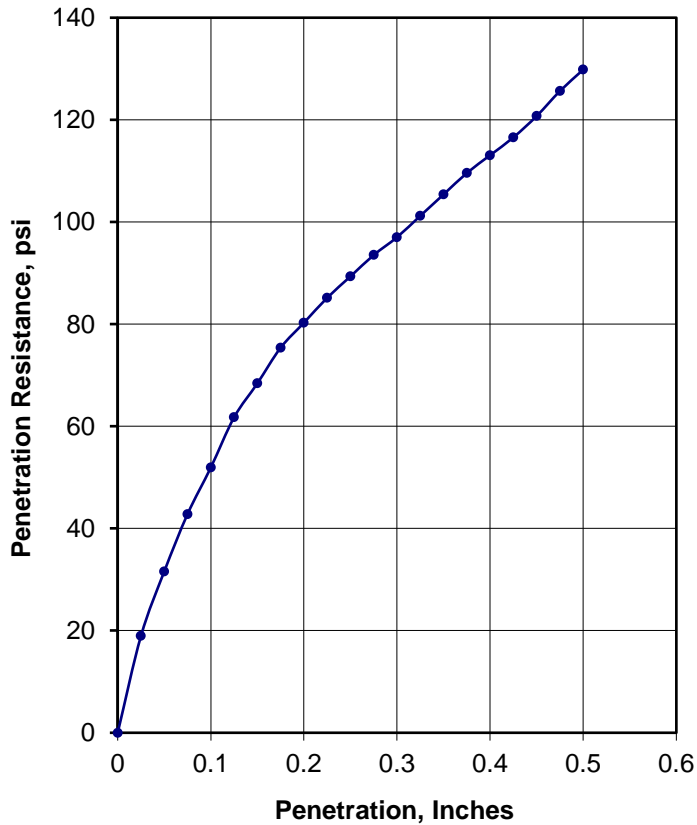
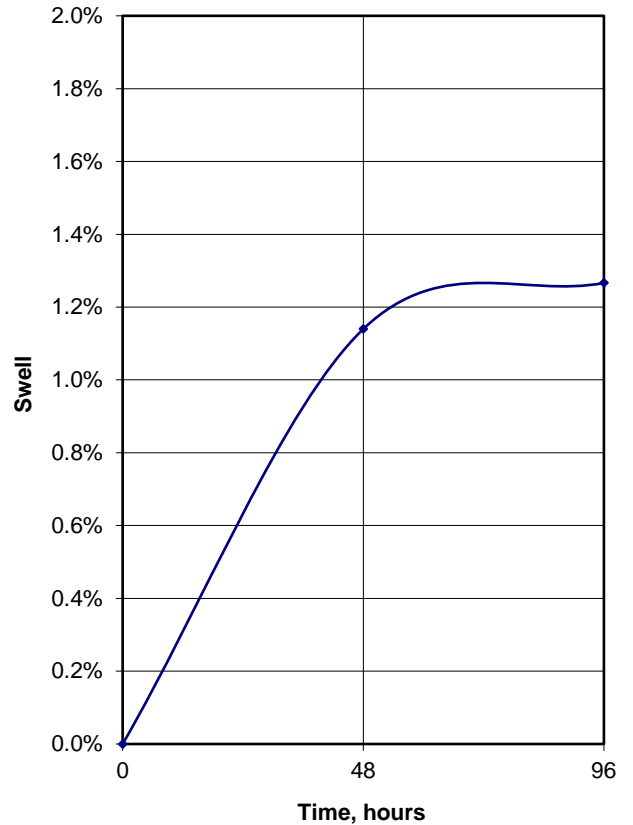
FIGURE NUMBER CBR 1

CBR at .1"	CBR at .2 "	Swell
	<b>5.2</b>	<b>5.4</b>	<b>1.3%</b>
	Dry Density	Moisture	Compaction
Molded	92.6	26.2%	99.1%
Soaked	88.0	32.9%	94.1%

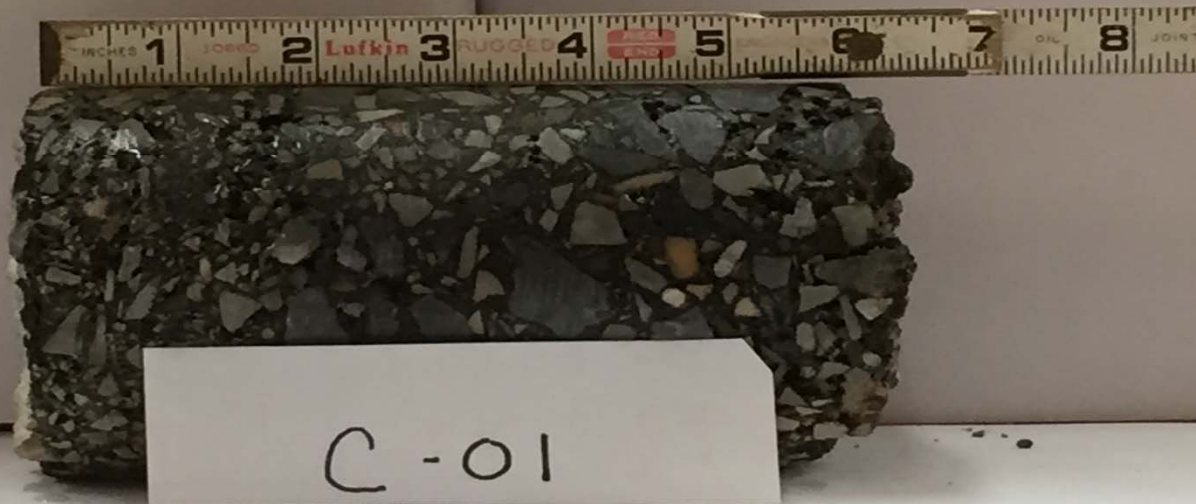
CORE C-01  
 EASTBOUND MAINLINE  
 ASPHALT 6.25 INCHES  
 BASE 7.25 INCHES

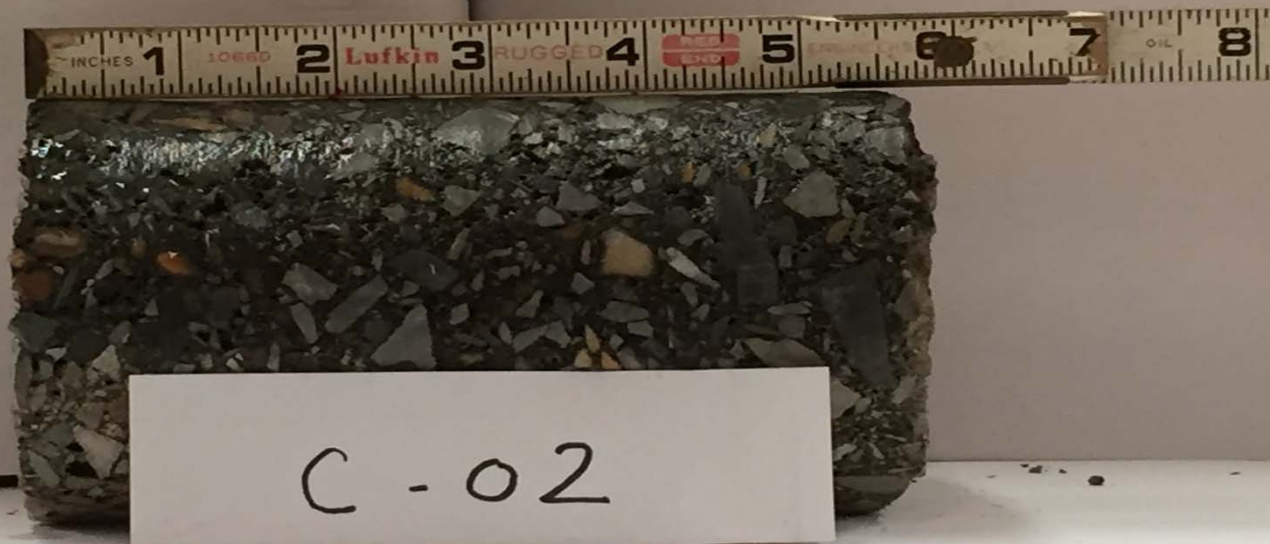
CORE C-02  
 EASTBOUND SHOULDER  
 ASPHALT 5.5 INCHES  
 BASE 11.5 INCHES

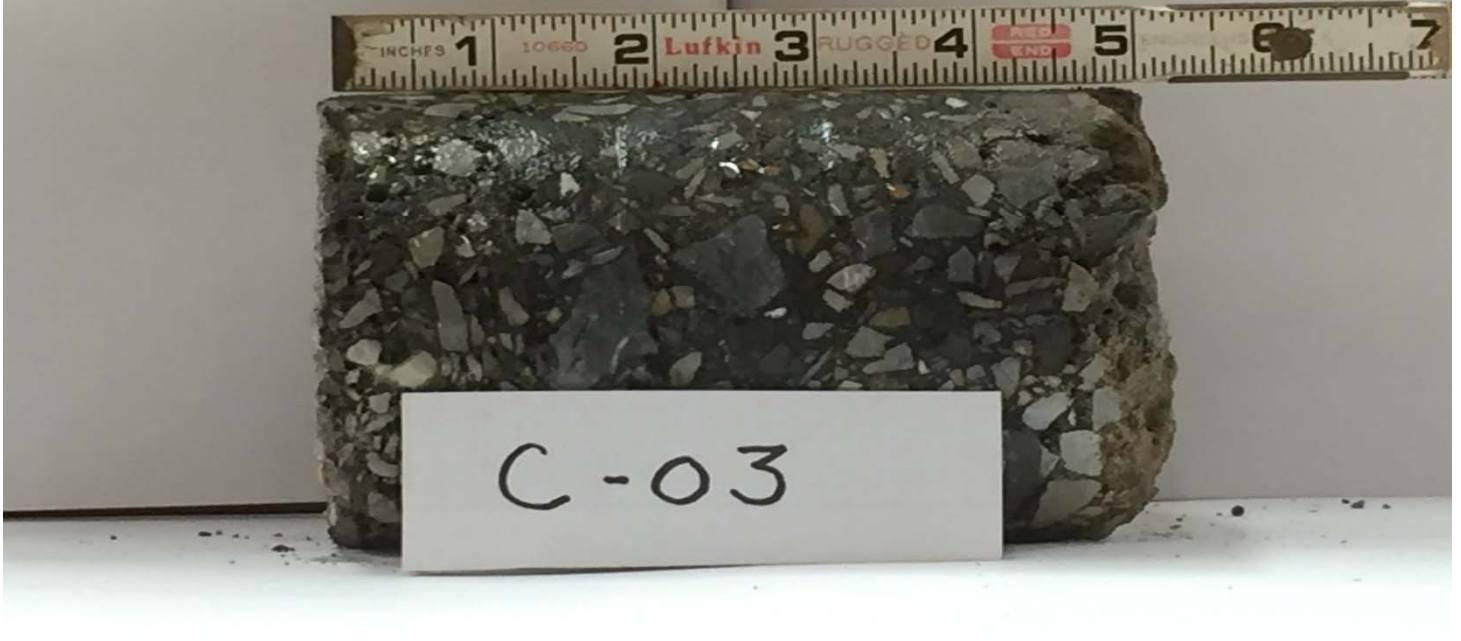
CORE C-03  
 EASTBOUND MAINLINE  
 ASPHALT 5.25 INCHES  
 BASE 7.75 INCHES

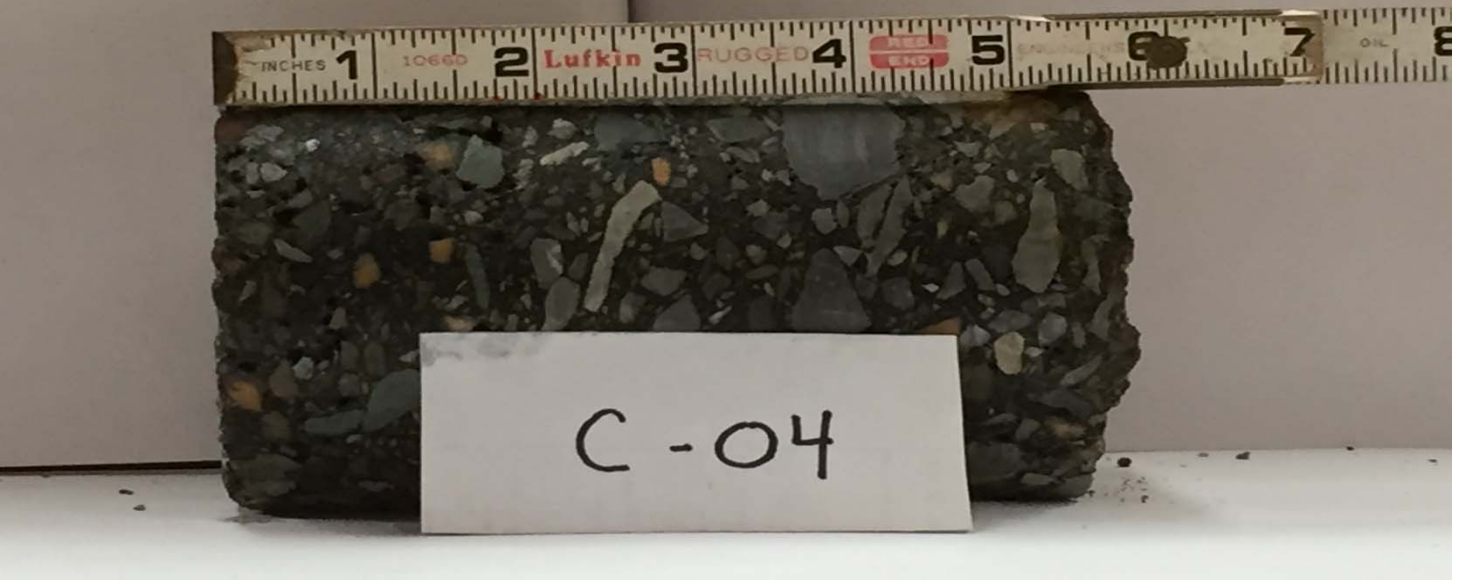
CORE C-04  
 EASTBOUND SHOULDER  
 ASPHALT 5.75 INCHES  
 BASE 6.25 INCHES

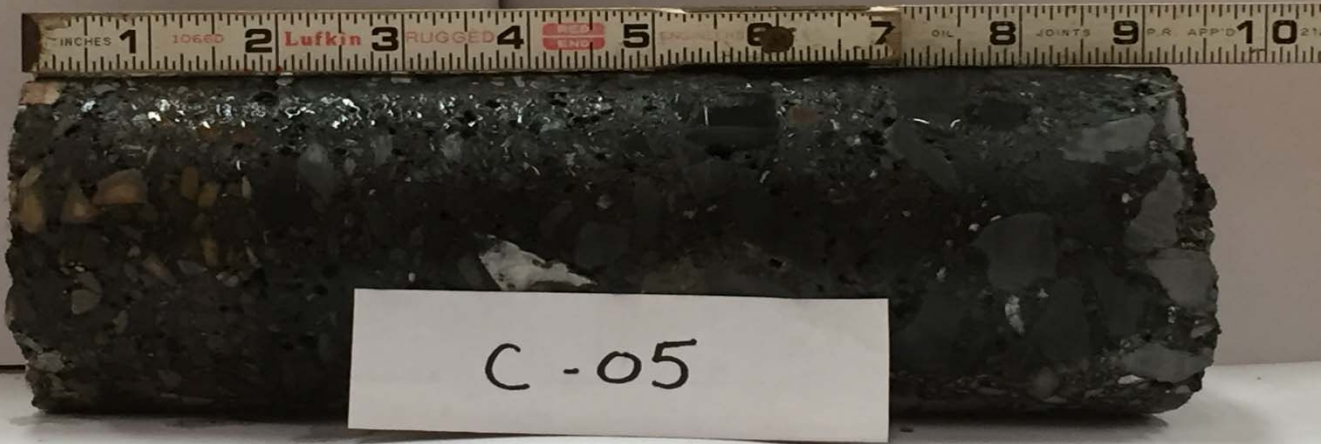
CORE C-05  
 EASTBOUND MAINLINE  
 ASPHALT 9.25 INCHES  
 BASE 7.75 INCHES

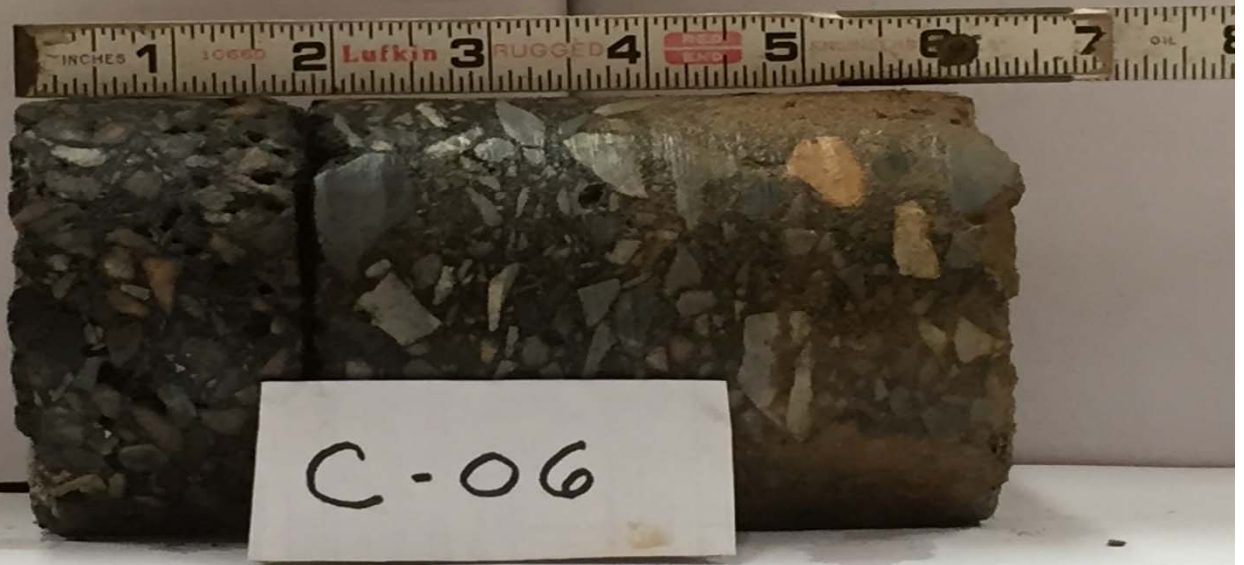
CORE C-06  
 EASTBOUND SHOULDER  
 ASPHALT 6 INCHES  
 BASE 11.5 INCHES
