REVISED GEOTECHNICAL ENGINEERING REPORT

**ROUTE 608 WIDENING
TINKLING SPRING ROAD
AUGUSTA COUNTY, VIRGINIA**

JOB NUMBER: 34049.002

Re: **Revised Geotechnical Engineering Report**
Route 608 Widening
Tinkling Spring Road (Route 608)
Augusta County, Virginia
Timmons Group Project No. 34049.002

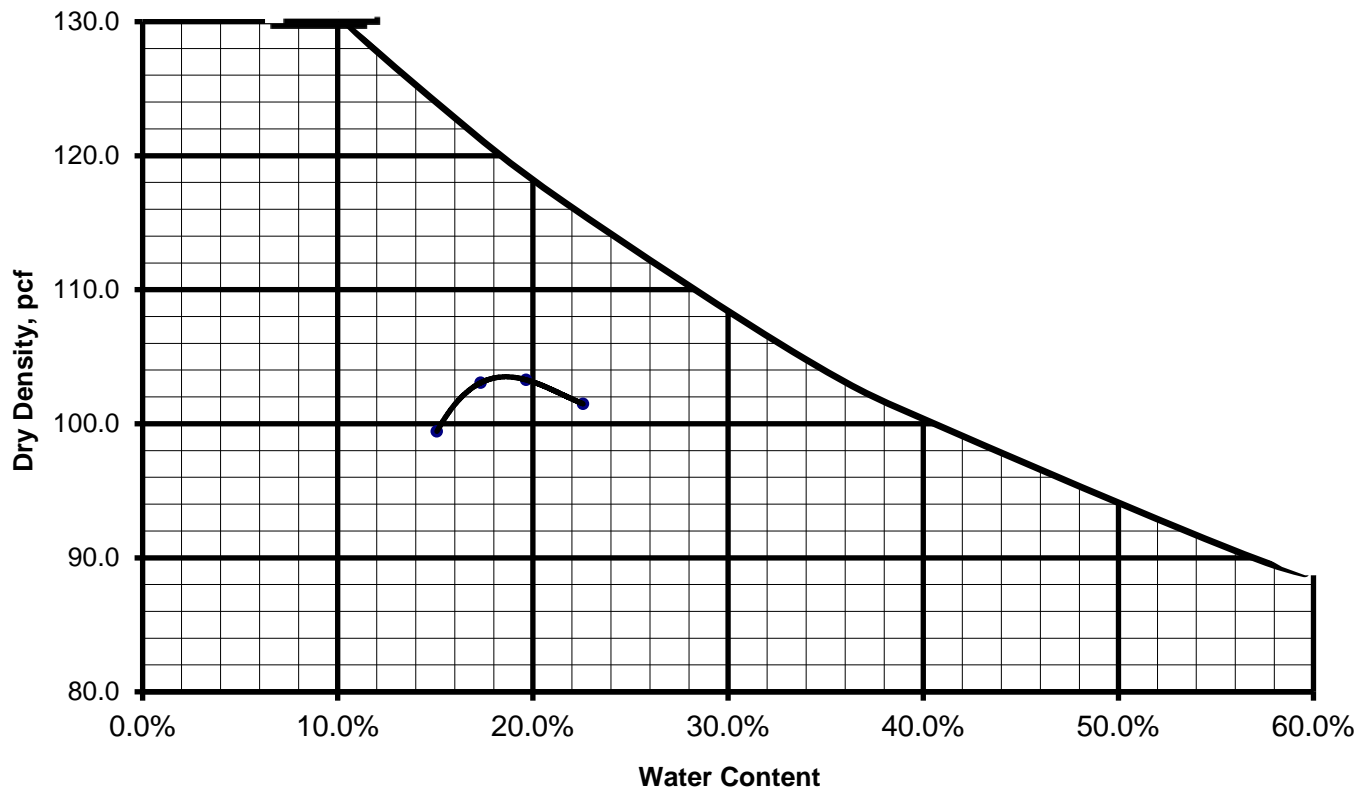
FIGURE NUMBER PR2

Project Number	34049.002		
Project Name	Route 608 Widening		
Location	HA-02A Bulk/ 0-1.5		
	Uncorrected	Rock Corrected Results	
Maximum Dry Density, pcf	103.5	116.6	
Optimum Moisture	18.5	13.1	
Material Description	Silty SAND with Gravel		
USCS	SM	AASHTO	A-2-7 (0.0)
Natural Moisture	16.5%	Percent Fines	29.0%
Liquid Limit	44	Plastic Index	15

Moisture-Density Curve

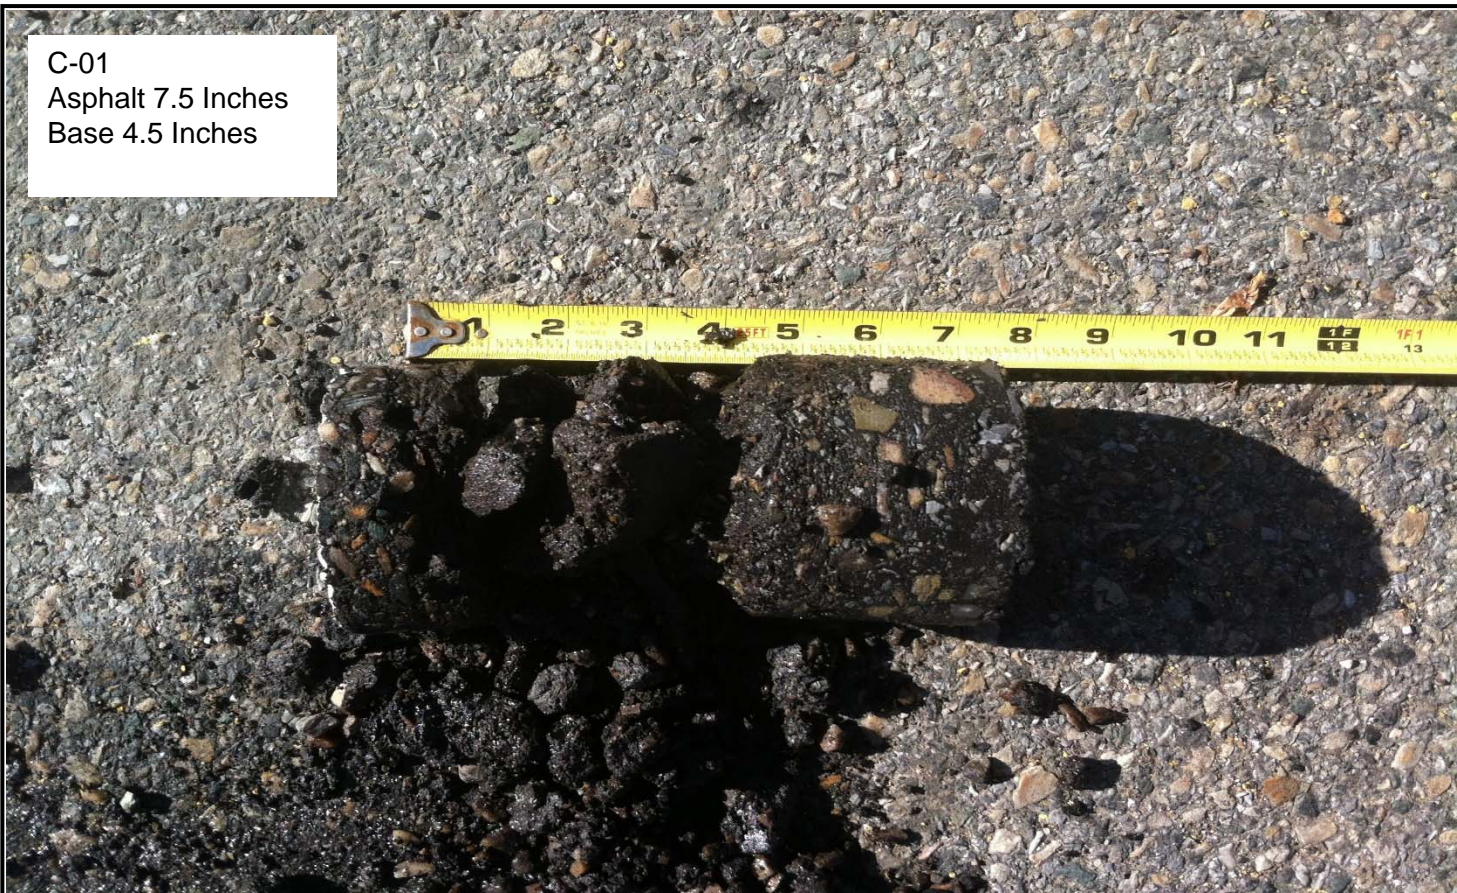
C-01
 Asphalt 7.5 Inches
 Base 4.5 Inches

The pavement sections at core locations C-1 and C-5 received a recent mill and overlay. The pavement near core C-1 received the mill and overlay after our coring operations. Because the core thicknesses at these two locations resulted in at least 7 inches of asphalt and the pavement has a new surface wearing course, it is our opinion that existing pavement sections at these core locations are sufficient to support the design traffic loads.

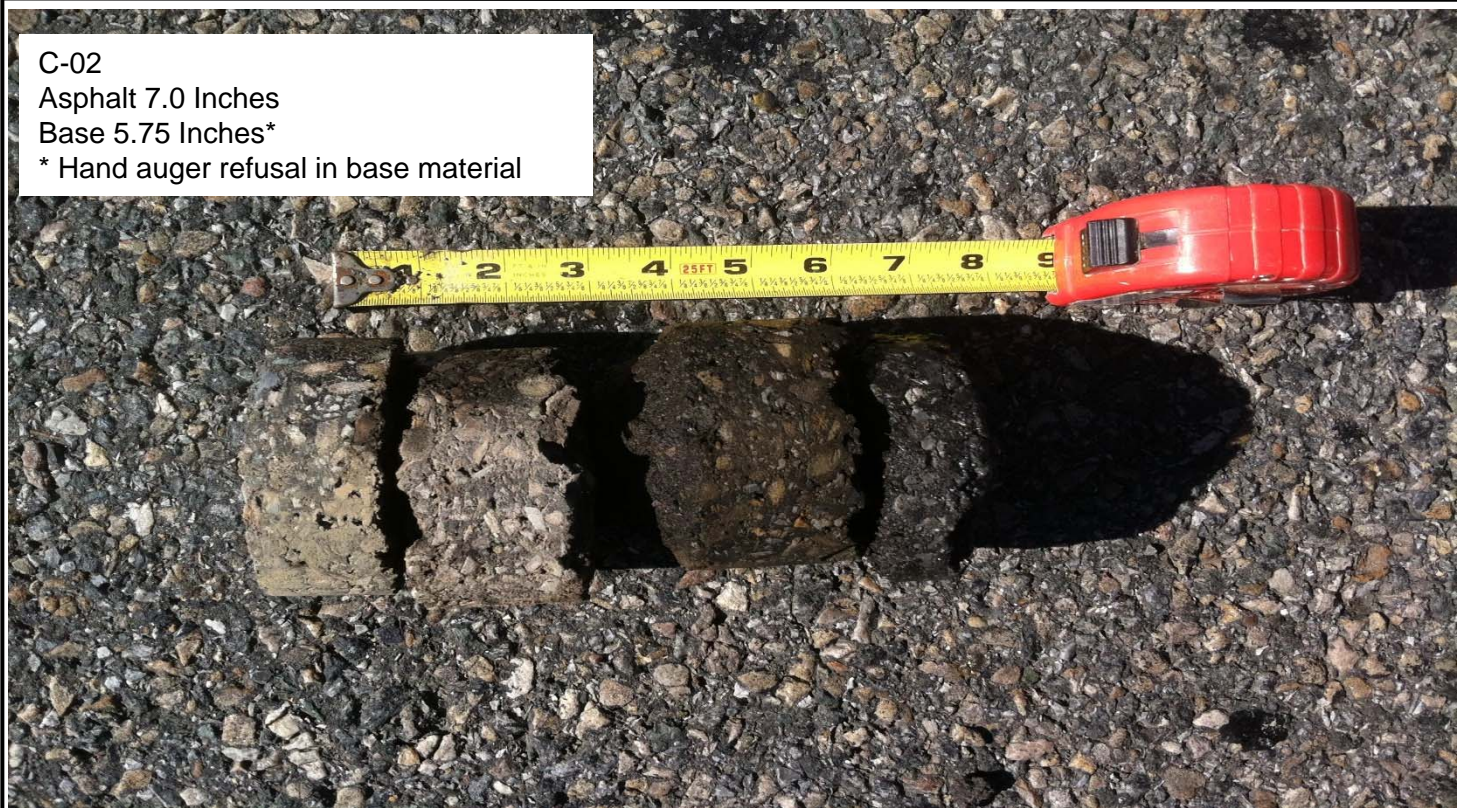
C-02
 Asphalt 7.0 Inches
 Base 5.75 Inches*
 * Hand auger refusal in base material

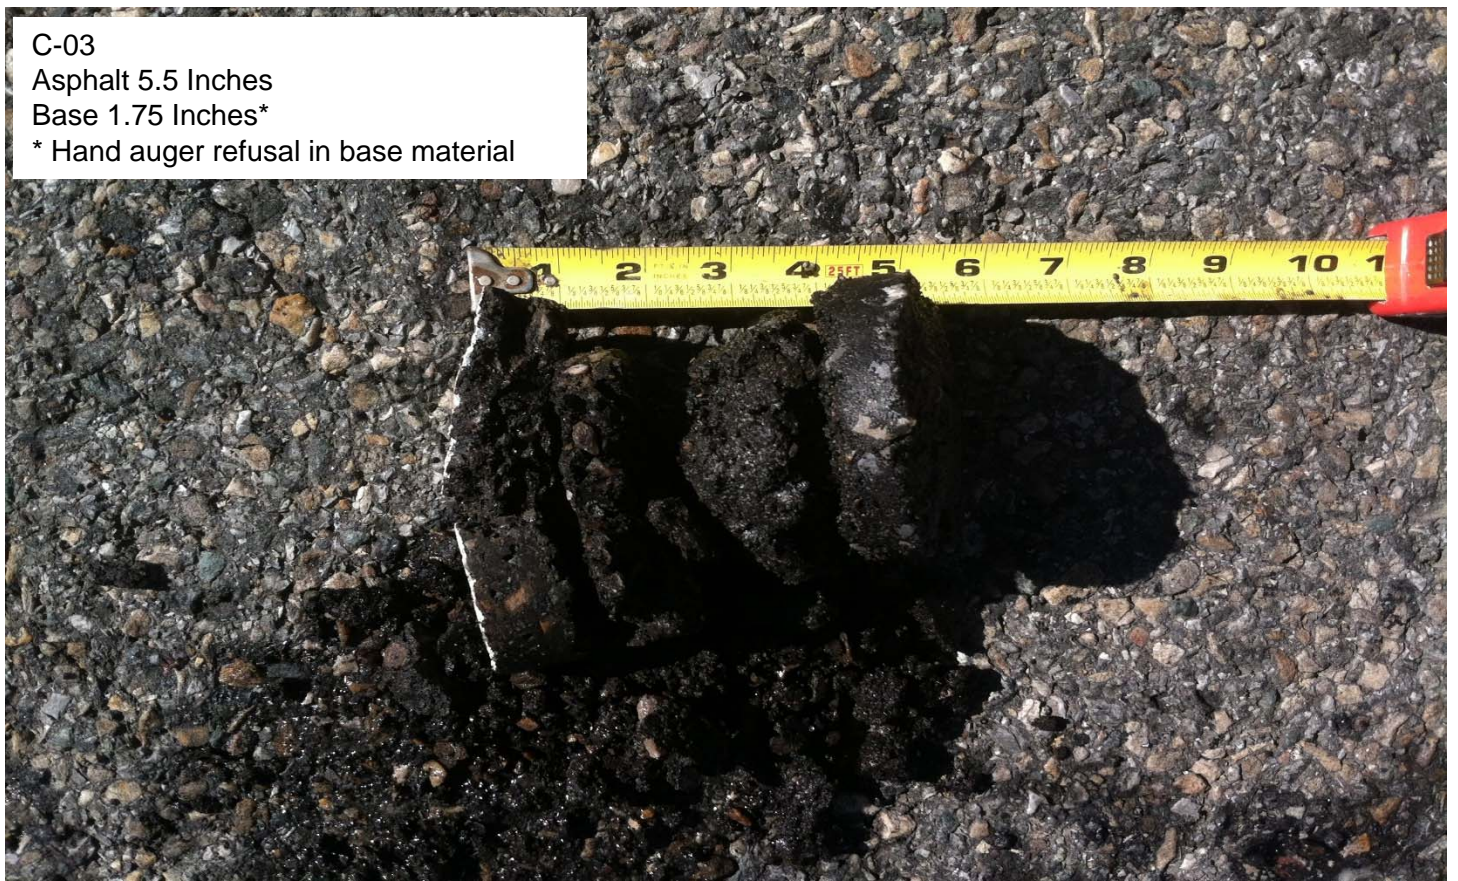
C-03
 Asphalt 5.5 Inches
 Base 1.75 Inches*
 * Hand auger refusal in base material

<u>Asphalt</u>	<u>Thickness</u>	<u>Condition</u>	<u>Coeff.</u>	<u>SN</u>
New	7"	New	0.44	3.08
Existing	5.5	Poor	0.22	1.21
Stone	4.5"	—	0.08	<u>0.36</u>

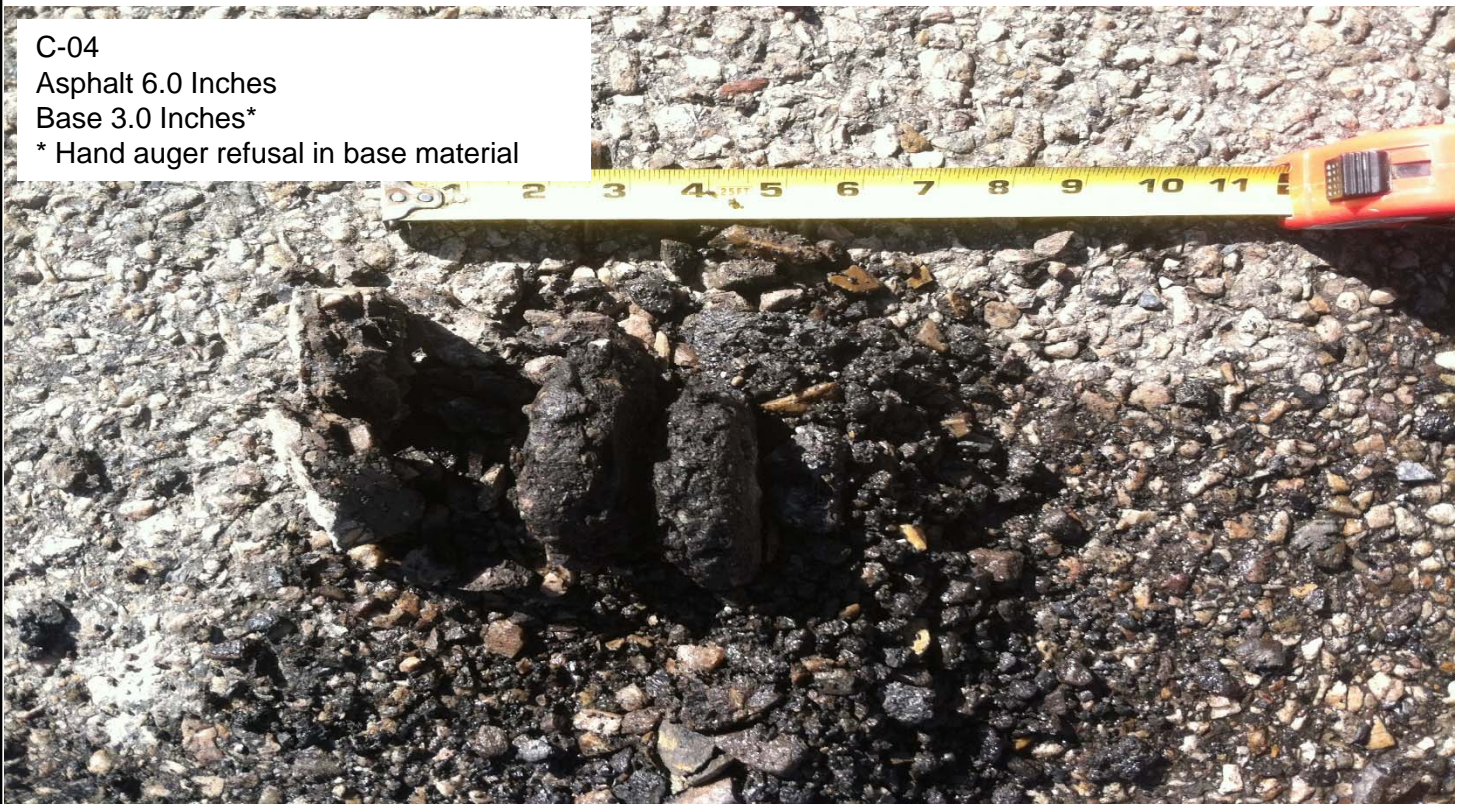
C-04
 Asphalt 6.0 Inches
 Base 3.0 Inches*
 * Hand auger refusal in base material

<u>Asphalt</u>	<u>Thickness</u>	<u>Condition</u>	<u>Coeff.</u>	<u>SN</u>
New	12"	New	0.44	5.28
Existing	6"	Poor	0.22	1.32
Stone	4.5"	—	0.08	<u>0.36</u>

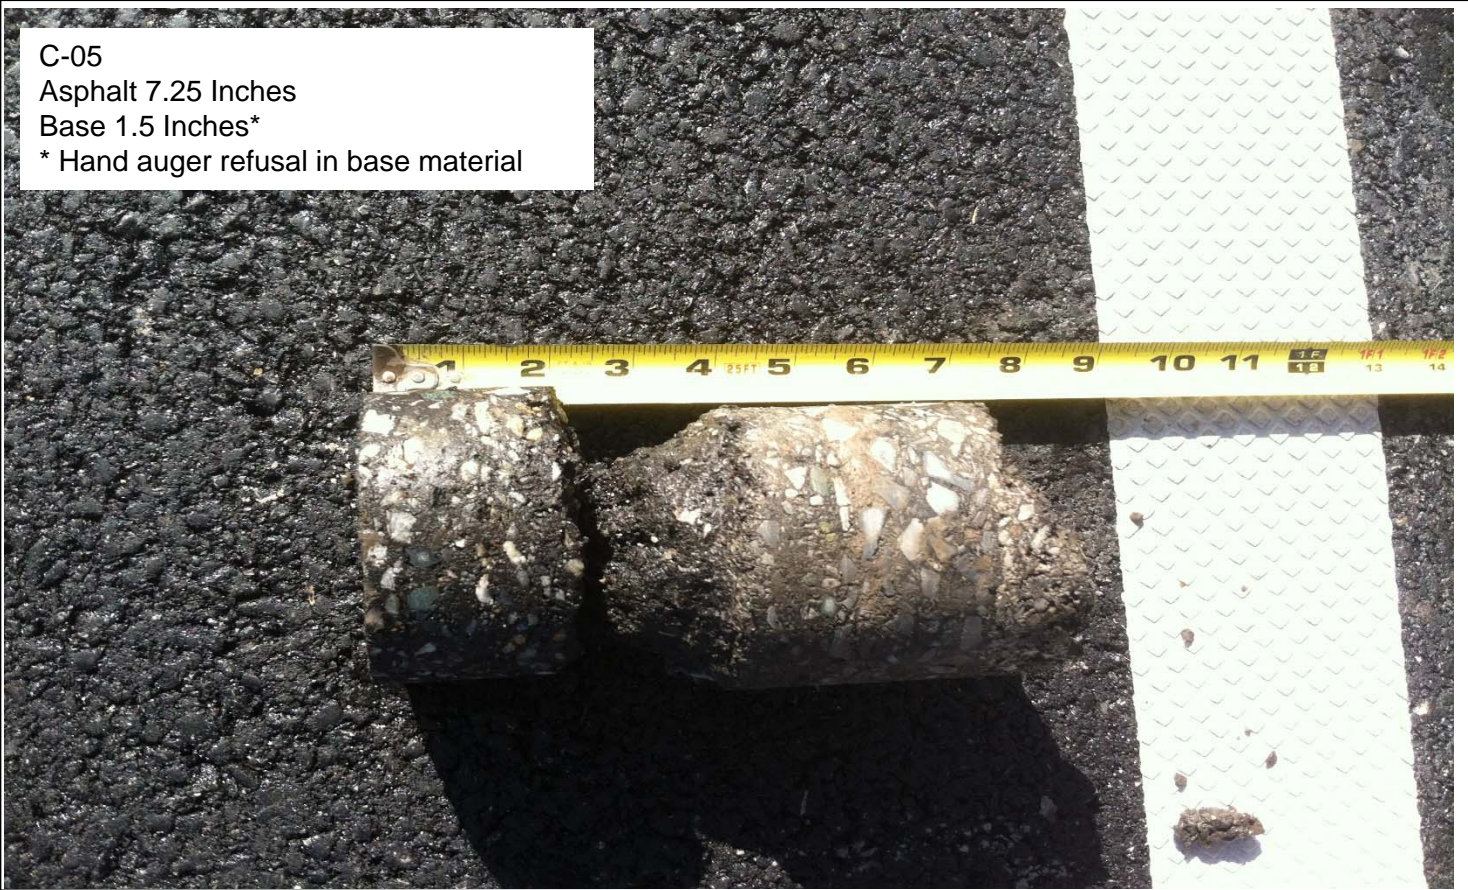
Asphalt core photo logs are provided in Appendix E. It is important to note that location of core C-05 had just received an approximately 2-inch mill and overlay from an adjacent construction project. In addition, the location of core C-01 has received a mill and overlay associated with a different construction project since the time of our coring.

C-05
Asphalt 7.25 Inches
Base 1.5 Inches*
* Hand auger refusal in base material

Accounting for recent overlay operations (from adjacent projects), for all existing pavements between Stations 312+50 and 324+00 that are to remain in place, we recommend that the existing pavement surface be milled to a depth of 2 inches prior to build-up or overlain with new pavements.
